**ANALYSIS OF COCKPIT VOICE RECORDER AND DIGITAL FLIGHT DATA RECORDER DATA  
EX AIR NEW ZEALAND DC 10 ZK NZP****Introductory Notes:**

# ANNEX E TO REPORT 79-139

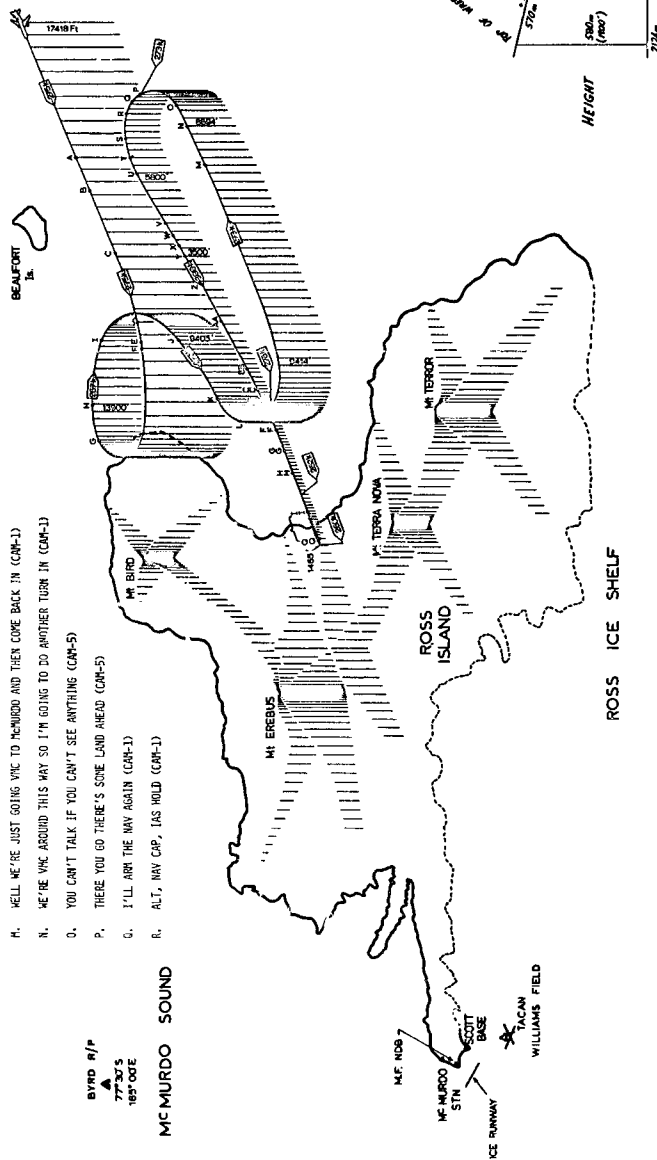
APPENDIX 3

EXTRACTS FROM THE COOPT VOICE RECORDER OF ZK-NZP

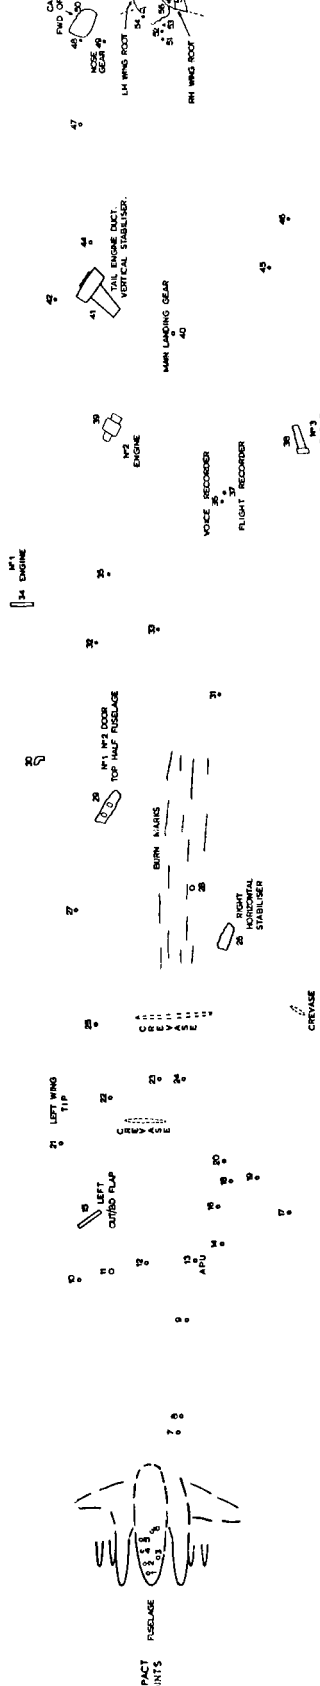
## SITE PLAN

KEY TO SITE PLAN OF WRECKAGE ZK-N2P

357 GRID  
HEADING
