**ANALYSIS OF COCKPIT VOICE RECORDER AND DIGITAL FLIGHT DATA RECORDER DATA  
EX AIR NEW ZEALAND DC 10 ZK NZP****Introductory Notes:**

APPENDIX 4  
TO ANNEX D REPORT 79-139

AIR NEW ZEALAND DC-10-30 ROSS ISLAND ANTARCTICA

# ANNEX E TO REPORT 79-139

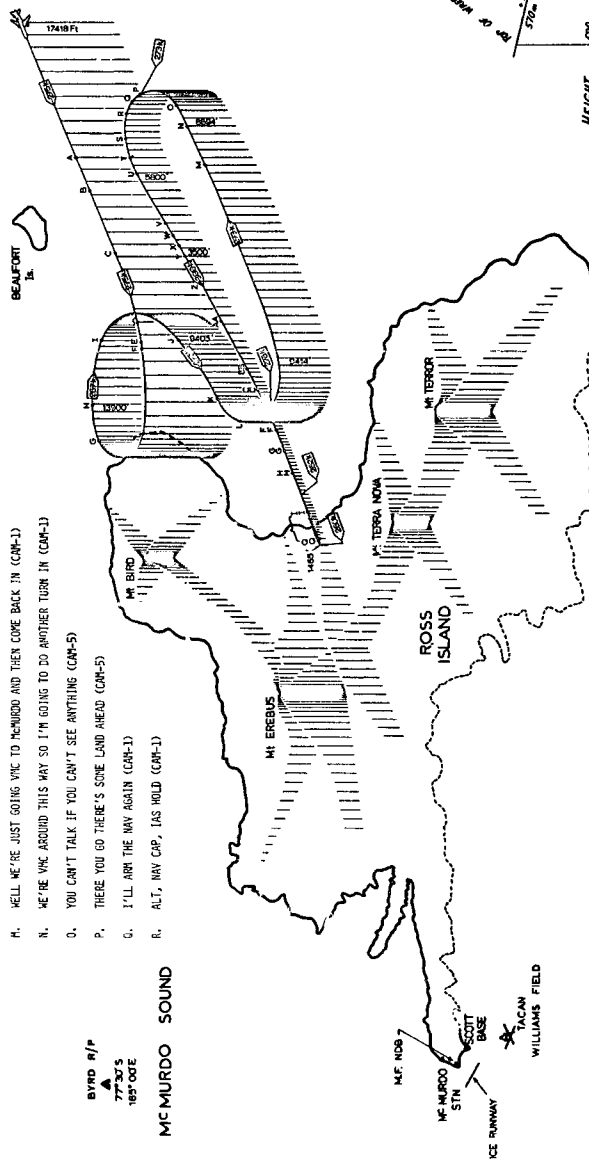
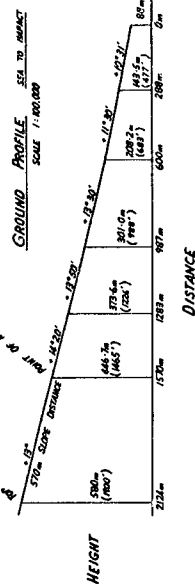
EXTRACTS FROM THE COOPT VOICE RECORDER OF ZK-NZP

- S. WE ARE NOW AT GOOD DESCENDING TO 2000 AND WE'RE VIC (RD0-2)
- T. WE HAD A MESSAGE FROM THE MIGHT VALLEY AND THEY'RE CLEAR OVER THERE (COP-1)
- U. THE TAYLOR OR THE MIGHT NOW OR DO YA? (COP-5) NO - I PREFER HERE FIRST (COP-1)

- V. I STILL CAN'T SEE VERY MUCH AT THE MOMENT - AS SOON AS I SEE SOMETHING THAT GIVES ME A CLUE AS TO WHERE WE ARE I'LL LET YOU KNOW (COP-5)
- W. ALTIETERS (COP-3)

- X. 29 - 29.30 (COP-1)
- Y. ALT. NAV TRACK, VERT SPEED (COP-2)
- Z. WHERE'S EREBUS IN RELATION TO US AT THE MOMENT? (COP-5) LEFT ABOUT (THIRTY) OR (THIRTY) 5 HILES (?) LEFT DO YA REGOR (?) - WELL I DON'T KNOW I THINK (?) I'VE BEEN LOOKING FOR IT (?) I THINK IT'LL BE (?) I'VE JUST THINKING OF ANY HIGH GROUND IN THE AREA THAT'S ALL (COP-3)

- AA. THAT'S THE EDGE (COP-5)
- BB. WEIGHT HAVE TO POP DOWN TO 1500 HERE I THINK (COP-1) PROBABLY SEE FURTHER IN ANYWAY (COP-2)
- CC. BIT THICK HERE EH (BERT)? YES MY MAXX DATA (COP-4)

- DD. YOU'RE REALLY A LONG TIME ON XXX INSTRUMENTS AT THIS TIME AREN'T YOU? (COP-1)
- EE. I REGON BIRD'S THROUGH HERE ... AND ROSS ISLAND'S THERE ... EREBUS SHOULD BE HERE (COP-5)

- FF. ALT HOLD (COP-2)
- GG. ACTUALLY THESE CONDITIONS DON'T LOOK VERY GOOD AT ALL DO THEY (COP-1) NO THEY DON'T (COP-5)
- HH. THAT LOOKS LIKE THE EDGE OF ROSS IS., THERE (COP-5)

- II. I DON'T LIKE THIS (COP-1)
- JJ. WE'RE 26 HILES AHEAD I'LL HAVE TO CLIB OUT OF THIS (COP-1)
- KK. IT'S CLEAR TO THE RIGHT AND WELLS AHEAD - YOU'RE CLEAR TO TURN RIGHT THERE'S NO HIGH GROUND IF YOU DO A 180 (COP-2) NO - NEGATIVE (COP-1)

- LL. (GPS) WOP-WOP PULL UP WOP-WOP
- MM. 500 FEET (COP-3)
- NN. (GPS) PULL UP
- OO. 400 FEET (COP-3)
- PP. WOP-WOP PULL UP WOP-WOP PULL UP
- QQ. GO ROUND POWER PLEASE (COP-1)

- A. I'LL HAVE TO DO AN ORBIT HERE I THINK (COP-1)
- B. WELL ACTUALLY ITS CLEAR OUT HERE IF WE CAN GET DOWN (COP-1)
- C. IT'S NOT CLEAR ON THE RIGHT HAND SIDE HERE (COP-2)

- D. WE'D LIKE FURTHER DESCENT OR WE COULD ORBIT IN OUR PRESENT POSITION WHICH IS APPROXIMATELY 42 HILES NORTH DESCENDING VIC. (RD0-2)
- E. I'LL DO AN ORBIT HERE TO GET DOWN I THINK (COP-1)

- F. WE ARE PRESENTLY DESCENDING THROUGH FLIGHT LEVEL 150 VIC AND THE INTENTION AT THE MOMENT IS TO DESCEND TO 1000 (RD0-2)
- G. TRANSPOUNDER NOW RESPONDING (COP-2)

- H. WE'VE LOST HIM AGAIN (COP-2)
- I. YOU'RE THROUGH 1000 ARE YOU GOING TO HOLD IT HERE? (COP-4)
- J. I'VE GOT TO STAY VIC HERE SO I'LL BE DOING ANOTHER ORBIT (COP-1)

- K. WE'RE MAINTAINING 1000 PRESENTLY 34 HILES TO THE NORTH OF MC MURDO (RD0-2)
- L. STILL NEGATIVE CONTACT ON WH WE'RE VIC - WE'D LIKE TO LET DOWN ON A GRID OF 180 AND PROCEED VISUALLY TO MC MURDO (COP-2)

- M. WELL WE'RE JUST GOING VIC TO MC MURDO AND THEN COME BACK IN (COP-1)
- N. WE'RE VIC AROUND THIS MAY SO I'M GOING TO DO ANOTHER TURN IN (COP-1)
- O. YOU CAN'T TALK IF YOU CAN'T SEE ANYTHING (COP-5)

- P. THERE YOU GO THERE'S SOME LAND AHEAD (COP-5)
- Q. I'LL RUN THE WAY AGAIN (COP-1)
- R. ALT. NAV CAP, IAS HOLD (COP-1)

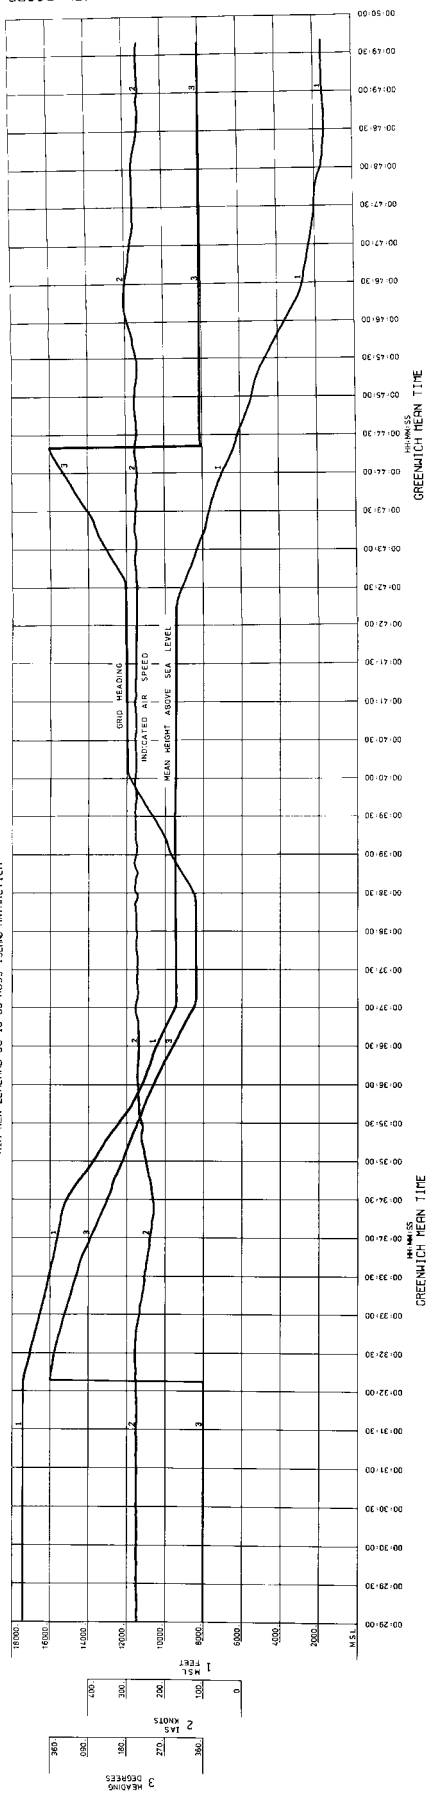
LOCATION - ROSS ISLAND ANTARCTICA  
AIRCRAFT - DC 10-30  
OPERATOR - AIR NEW ZEALAND  
DATE - 08 NOV 79  
FLIGHT NO - 95-3  
REPORT NO - 85-3  
RECORDED S/N - 2481  
RECORDER M/N - 500-577A

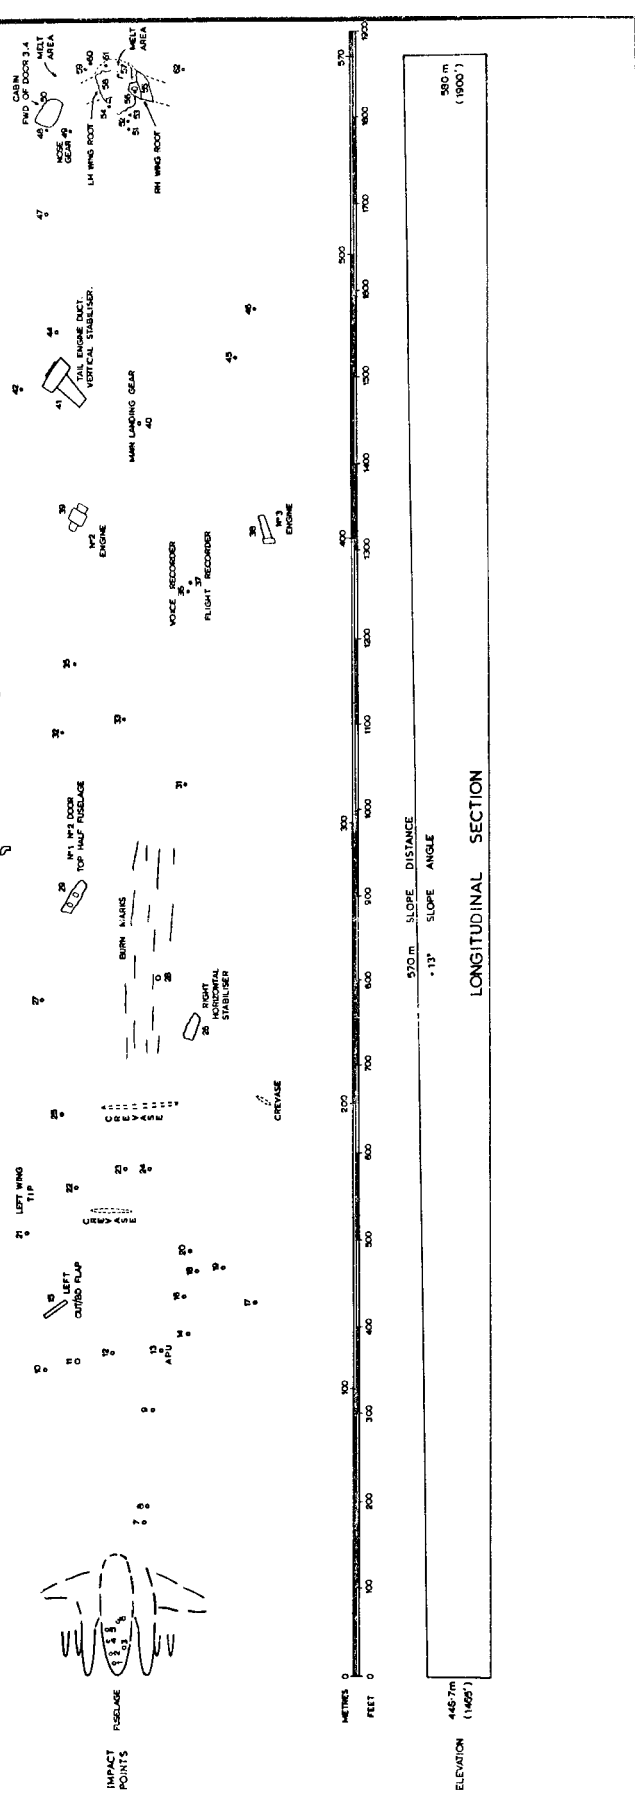
## SITE PLAN

357 GRID  
HEADING

ELEVATION  
445.7m  
(1462')

570m SLOPE DISTANCE  
13° SLOPE ANGLE
